Manhole Inspection Summary

Manhole # S69Q__008MH

Insp Date: **4/22/08 9:00 AM**

Location Address: **1504 Dundalk Ave.**

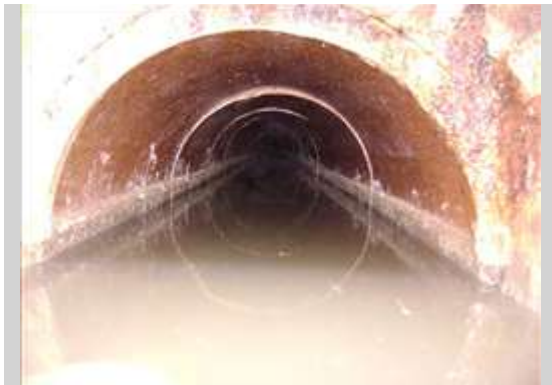
6 O'Clock Inflow

24 in. Circular Gravity Sewer
Pipe In @ 6 O'Clock

Pipe Height: **24** (in.) Rod and Bar (Angled)
Pipe Material: **Clay** ☐ Pipe Lined
Invert Depth: **12.67** (ft.) Flow Characteristics: **Slow**
Deposits: ☒ **None** ☐ Mud ☐ Sludge ☐ Debris ☐ Grease
Silt Depth: (in.) Deposits Extent:
Infiltration: **None** Pipe Seal Cond: **Sound**

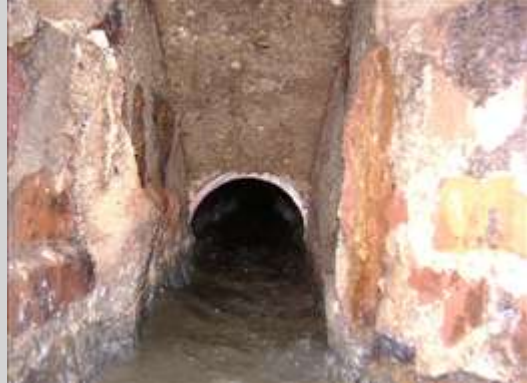
9 O'Clock Inflow

10 in. Circular Gravity Sewer

Pipe In @ 9 O'Clock

Pipe Height: **9.6** (in.) Rod and Bar (Angled)

Infiltration: **None** Pipe Seal Cond: **Sound**
